B About the inspection (continued)

Overall opinion

This property is generally in poor condition. There have been repairs identified however and these are listed further on in the report.

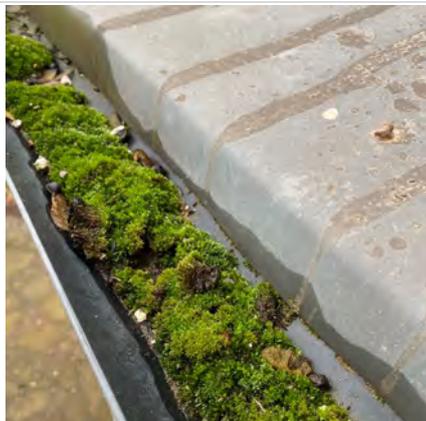
(Condition Rating 2)

There is vegetation growing from the gutters to the front bay.

Cost of associated remedial work detailed in Section C, R1.

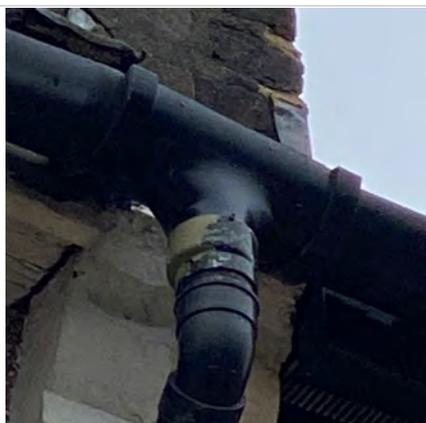
(Condition Rating 2)

There is evidence of a leaking downpipe to the front.

Cost of associated remedial work detailed in Section C, R2.

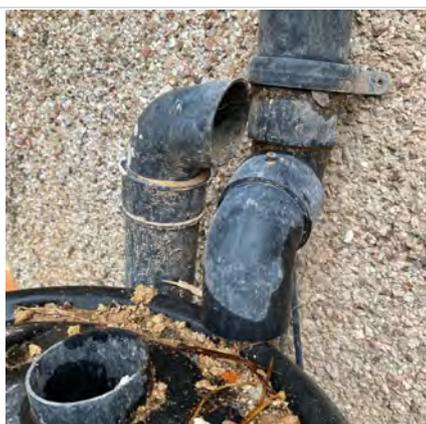
(Condition Rating 2)

The downpipe servicing the front bay is disconnected.

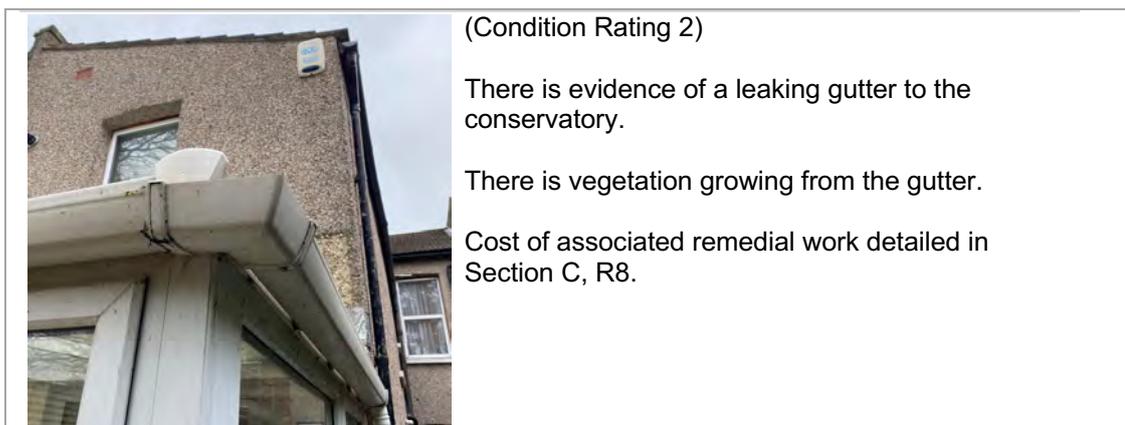
(Condition Rating 2)

There is evidence of a leaking gutter to the conservatory.

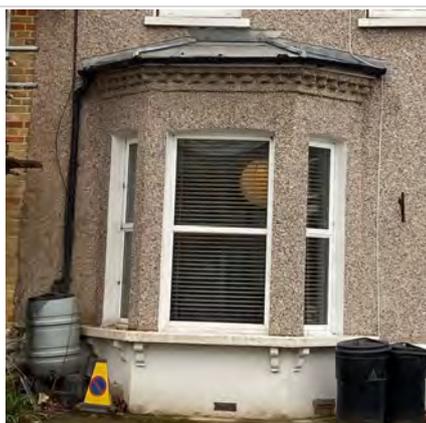
There is evidence of movement in the form of distortion to the front bay however, this does not appear to be progressive and we believe this to be historical.

Where there is evidence of previous movement to the property, it would be prudent to maintain insurance cover to ensure there is cover in the event of any future claim of movement.

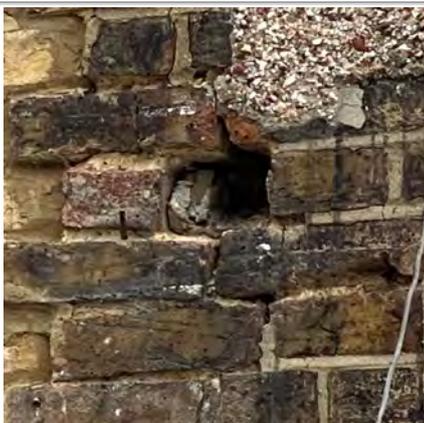
(Condition Rating 2)

There is a missing brick adjacent to the conservatory to the rear.

Cost of associated remedial work detailed in Section C, R7.

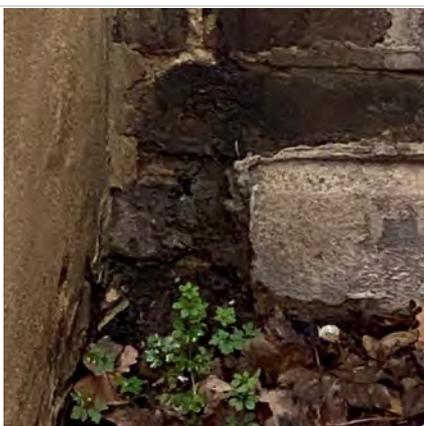
(Condition Rating 2)

Blown plinth:

Cost of associated remedial work detailed in Section C, R9.

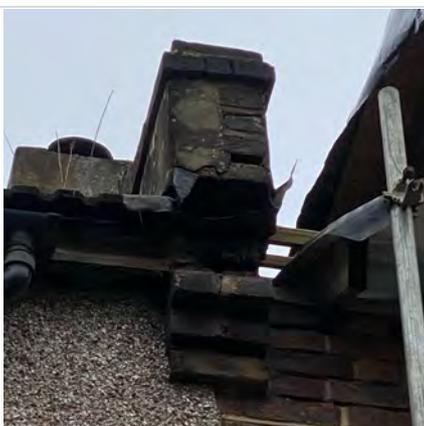
(Condition Rating 3)

There is missing brickwork to the parapet wall to the rear at the time of inspection. This is likely to be due to the works carried out by the neighbouring property.

R11	Allow to remove redundant timber post.		£50
R12	Allow to restitch missing brickwork. Brick pointing: Rake out existing joints of brickwork minimum of 12mm and repoint brickwork in mortar to match existing.		£1000

Cost of associated remedial work detailed in Section C, R12.

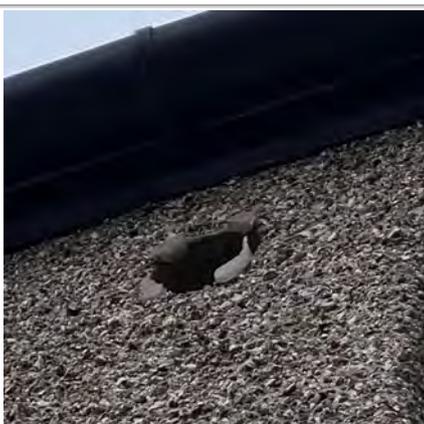
(Condition Rating 2)

Making good:

R13	Allow to make good to rear external wall.	£600
R14	Tanking basement: This is subject to the nature of use of the basement, as most basements have damp. As long as you do not store items that can be damaged by damp, tanking will not be required. Clean off surfaces, prime surface and apply keying mix of cement: sand: slurry: apply 2 coats of asphalt to BS 6925, tanking and damp-proofing 20mm thick, internal angle fillets and make good.	£10000
R15	Plastering Back To Brick: Remove defective plaster from wall, prepare existing background to provide a good key, re-plaster (bonding coat and skim) to match existing. Including all necessary angle beads and plaster stops.	£500
R16	Loose / Creaking Floors: Take up {creaking} floorboards in area including de-nail joists, clear debris, punch in nails, level wall plates and girders, make good including extra noggins as required and {relay} floorboards. This may simply be the result of poor workmanship. Floor Not Level: Allow for further investigation under the floor due to this not being level. This may simply be the result of poor workmanship.	£300

Cost of associated remedial work detailed in Section C, R13.

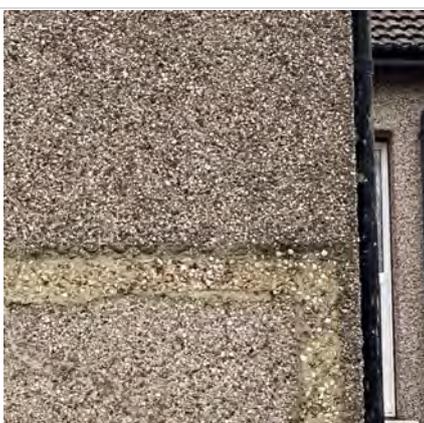
(Condition Rating 2)

Pebbledash:

Cost of associated remedial work detailed in Section C, R42.

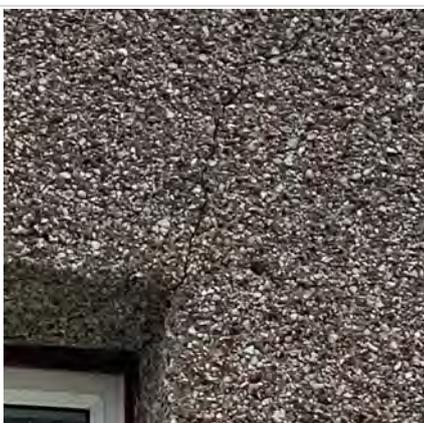
(Condition Rating 2)

Structural movement:

As per BRE digest 251, the crack(s) have a category of damage rating 2.

We recommend the cracks to the right-hand party wall and the landing walls be monitored by a structural engineer to ascertain if they are progressive.

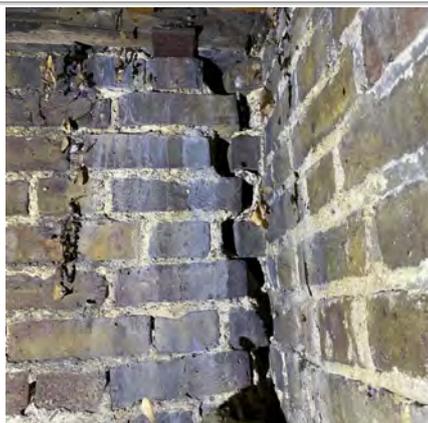
(Condition Rating 3)

Structural movement:

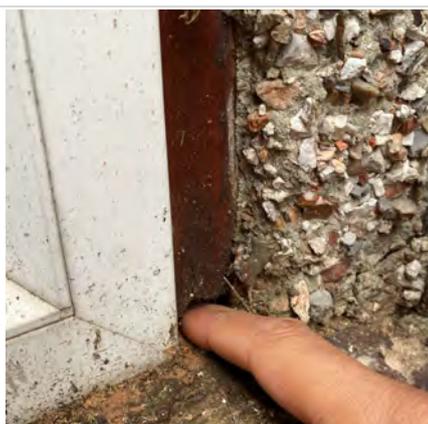
(Condition Rating 2)

Powder Coated Aluminium Window Replacement: Although functional, the powder coated aluminium windows are generally at the end of their life cycle and would benefit from full replacement.

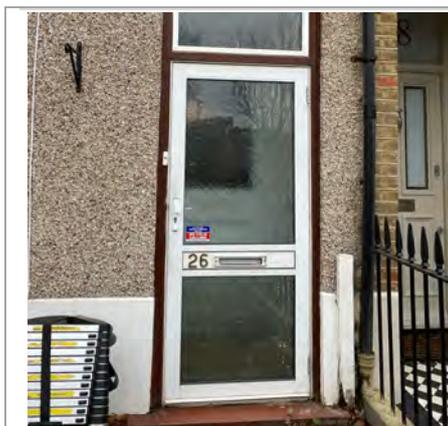
(Condition Rating 2)

Replace Door(s):

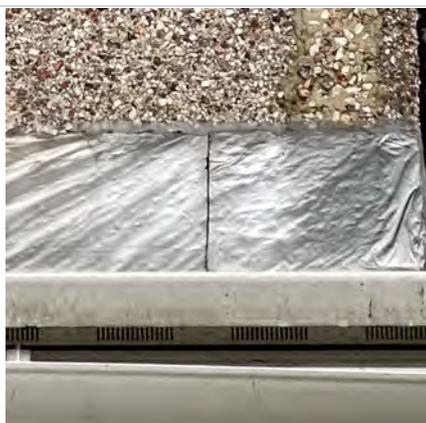
(Condition Rating 2)

The roof is dressed to the wall with flash band which is typically use only as a temporary solution.

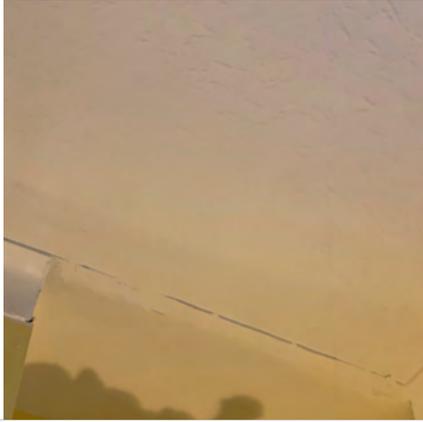
(Condition Rating 2)

Skim Ceiling:

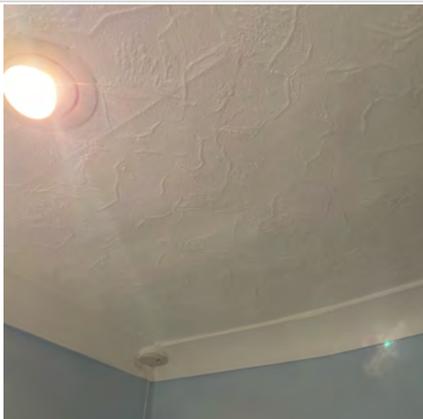
(Condition Rating 2)

Replace Ceiling:

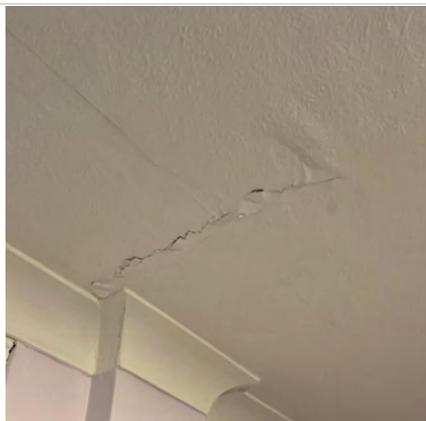
(Condition Rating 2)

Skim Ceiling:

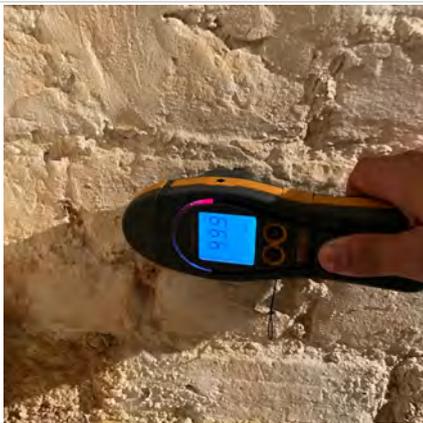
Basement 1

(Condition Rating 3)

Penetrating Damp:

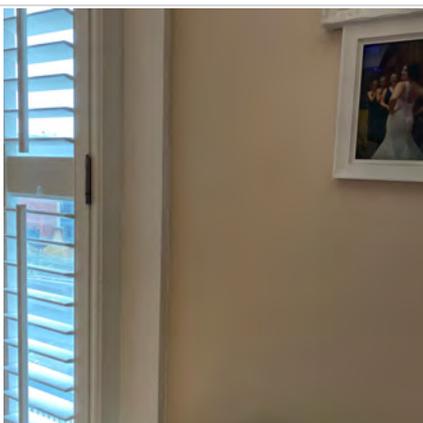
(Condition Rating 2)

Defective Plaster:

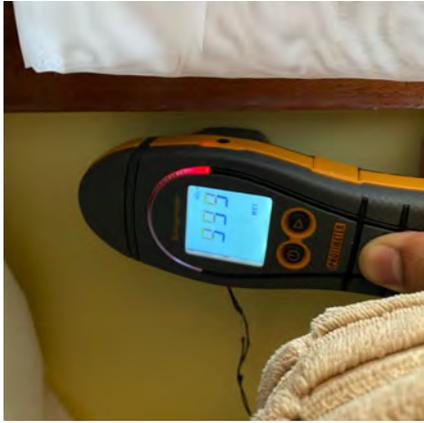
(Condition Rating 3)

Penetrating Damp:

Cost of associated remedial work detailed in Section C, R21.

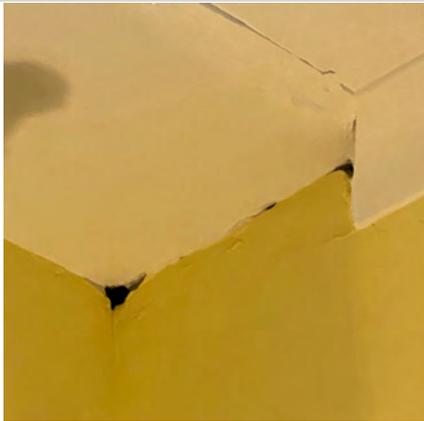
(Condition Rating 2)

Making good required to the rear wall.

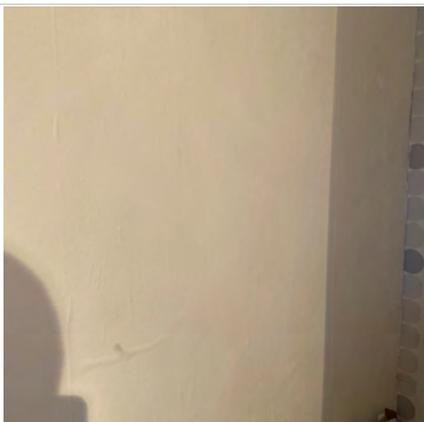
(Condition Rating 2)

Defective Plaster:

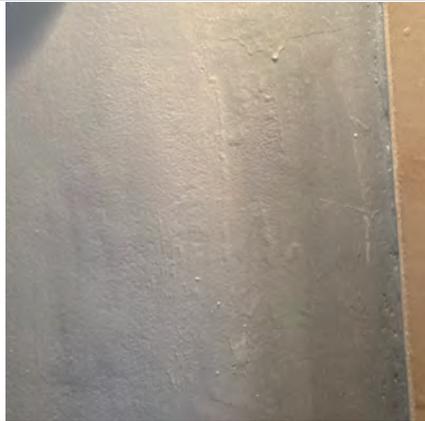
(Condition Rating 2)

Defective Plaster:

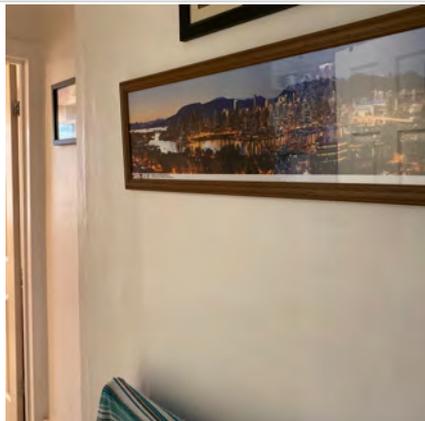
(Condition Rating 2)

Defective Plaster:

Cost of associated remedial work detailed in Section C, R29.

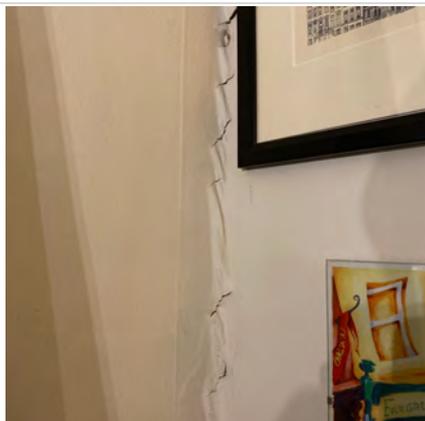
(Condition Rating 3)

Potentially Progressive Movement:

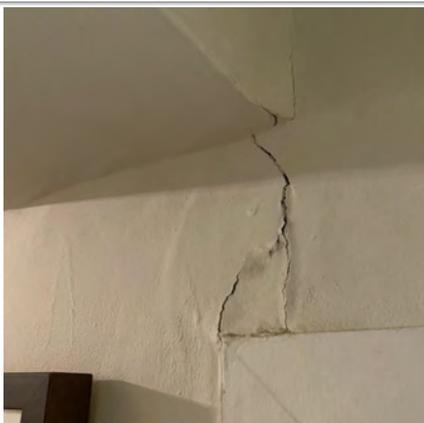
(Condition Rating 3)

Potentially Progressive Movement:
Subject to the movement to the right-hand party wall, there is also evidence of movement in the form of vertical cracks to the left-hand side wall of the hall. We recommend this be monitored with a digital calliper to ensure this is not progressive.

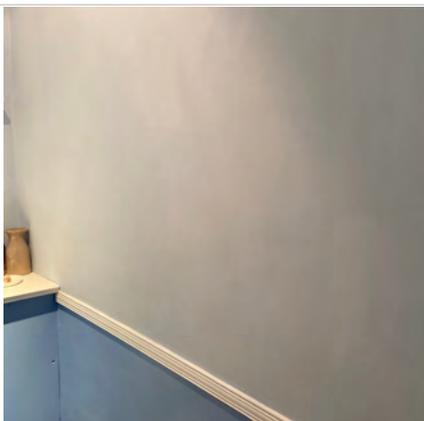
(Condition Rating 2)

Defective Plaster:
There is blown plaster that would benefit from being re-plastered.

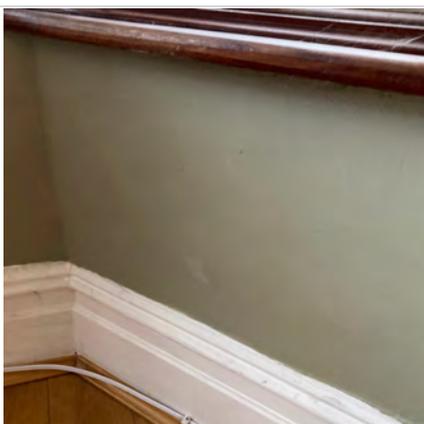
(Condition Rating 2)

Defective Plaster:
There is blown plaster that would benefit from being re-plastered.

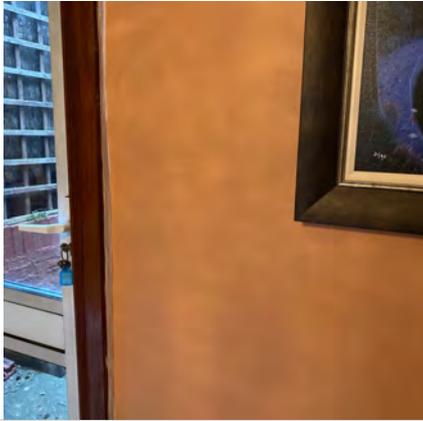
(Condition Rating 2)

Defective Plaster:

Cost of associated remedial work detailed in Section C, R34.

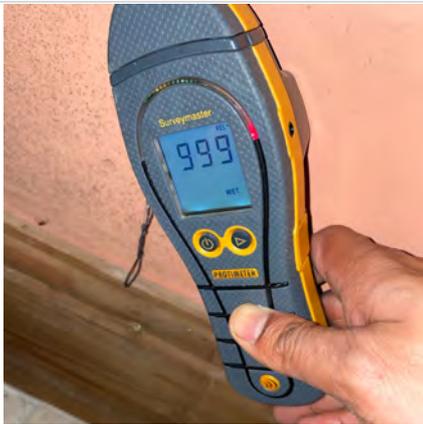
(Condition Rating 3)

Rising Damp:

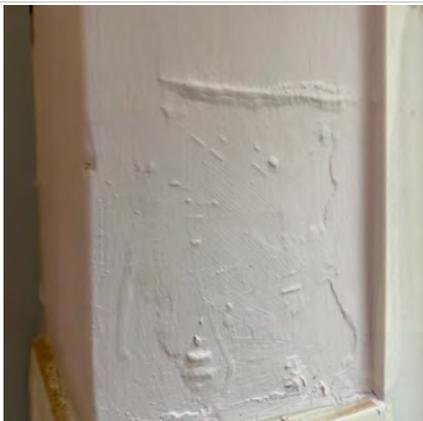
(Condition Rating 2)

Defective Plaster:

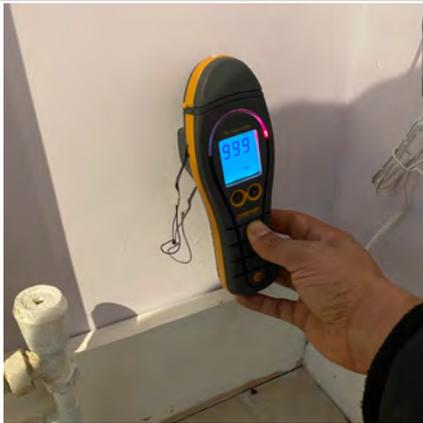
(Condition Rating 3)

Rising Damp:

Cost of associated remedial work detailed in Section C, R50.

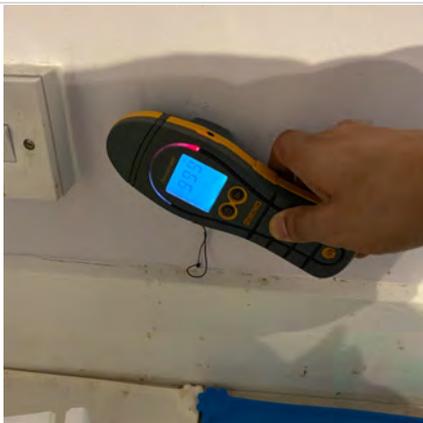
(Condition Rating 3)

Rising Damp:

Cost of associated remedial work detailed in Section C, R51.

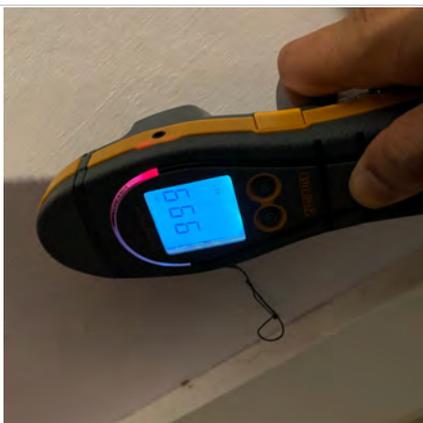
(Condition Rating 3)

Rising Damp:

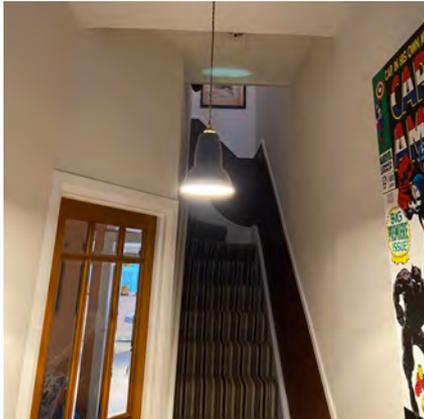
(Condition Rating 2)

Defective Plaster:

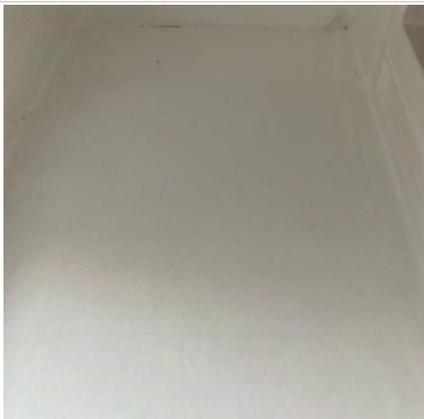
(Condition Rating 2)

Defective Plaster:

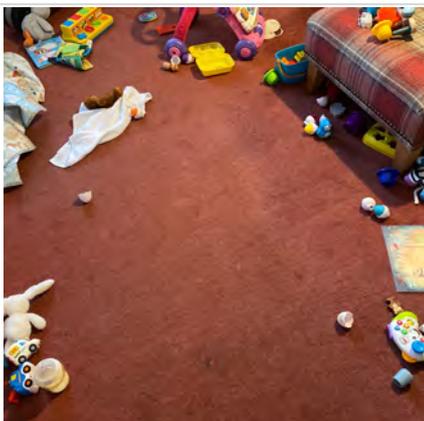
(Condition Rating 2)

Loose Floorboards:

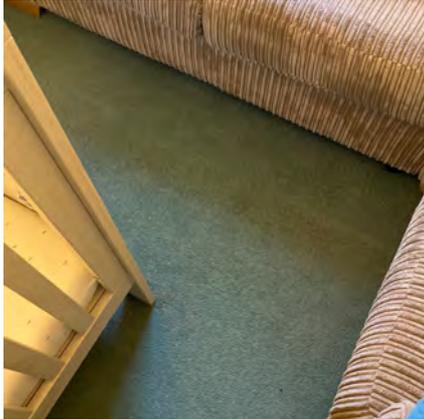
(Condition Rating 2)

Loose Floorboards:

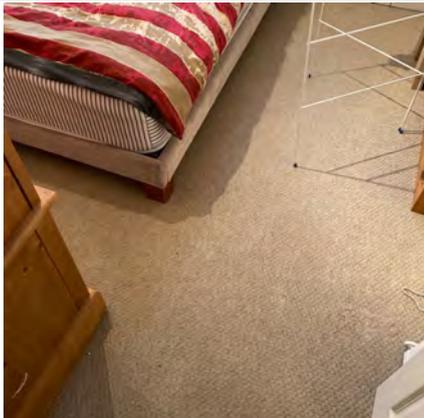
(Condition Rating 2)

Loose Floorboards:

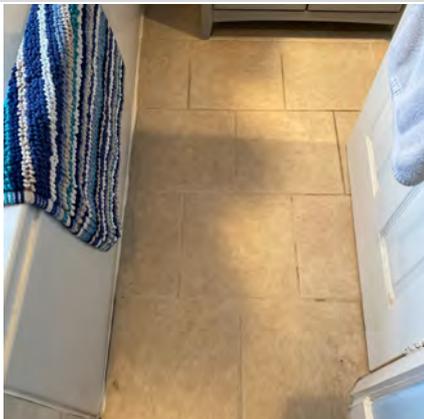
(Condition Rating 2)

Sloping Floors:

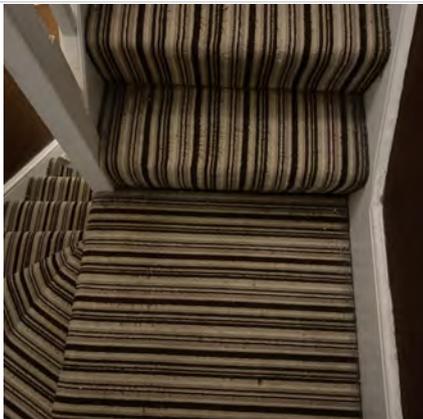
(Condition Rating 2)

Loose Floorboards:

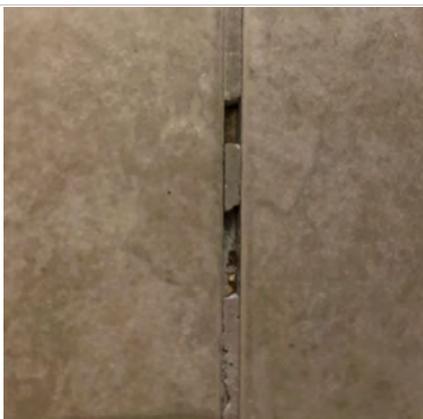
(Condition Rating 2)

Grouting to tiles. Rake out old grouting and repoint with waterproof grout and leave watertight.

R36	The tiles would benefit from being re-grouted.	£200
R37	Floor Not Level: Allow for further investigation under the floor due to this not being level. This may simply be the result of poor workmanship.	£300
R38	Skim Ceiling: Prepare, scrim cracks and apply 3mm skim plaster to ceiling including all labours.	£300
R39	Plastering Back To Brick: Remove defective plaster from wall, prepare existing background to provide a good key, re-plaster (bonding coat and skim) to match existing. Including all necessary angle beads and plaster stops.	£500
R40	Fire door: Renew internal door of any size by taking off existing and replacing with HALF HOUR FIRE CHECK DOOR of similar pattern to existing	£500

Cost of associated remedial work detailed in Section C, R36.

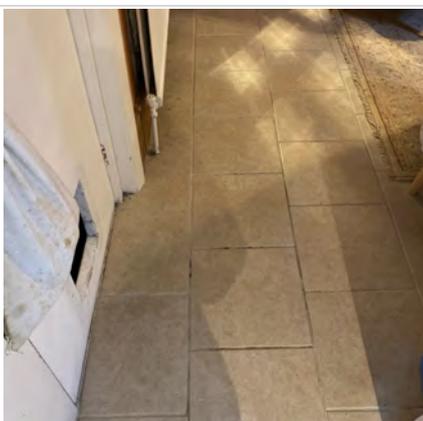
(Condition Rating 2)

Sloping Floors:

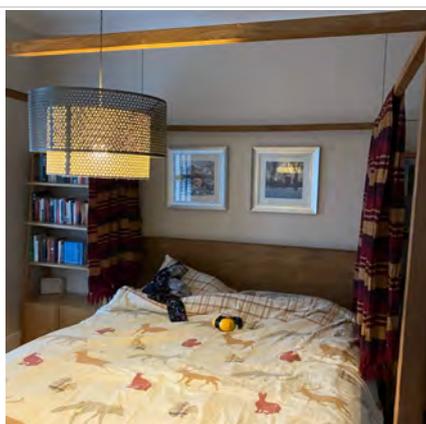
(Condition Rating 2)

No ventilation to chimney breast. We recommend this be vented with a plaster vent.

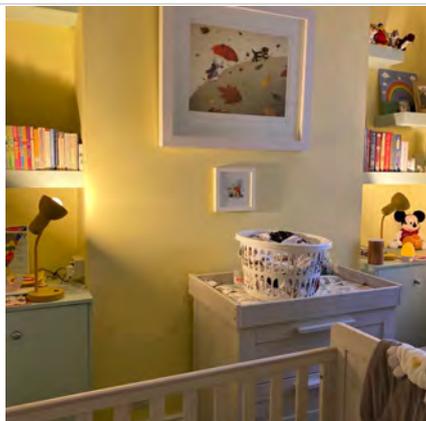
(Condition Rating 2)

No ventilation to chimney breast. We recommend this be vented with a plaster vent.

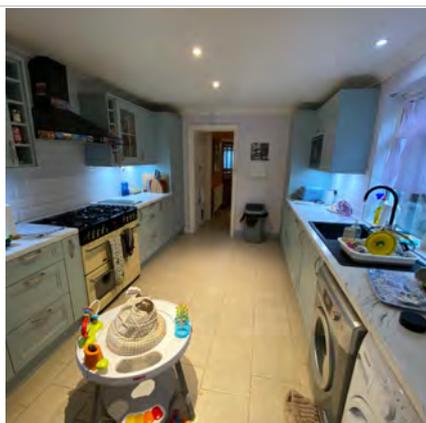
Used:

The kitchen units and components in general are showing wear and tear, but are functional.

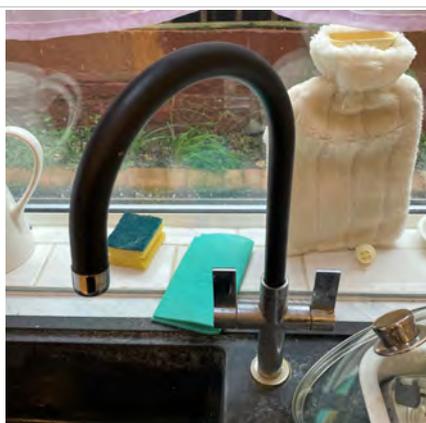
(Condition Rating 2)

The sink tap is loose, we recommend this be secured.

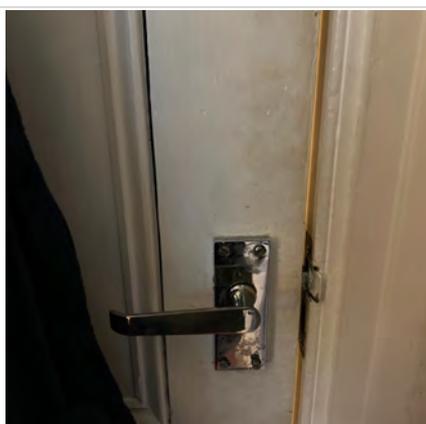
(Condition Rating 2)

The door does not close correctly and needs to be eased and adjusted.

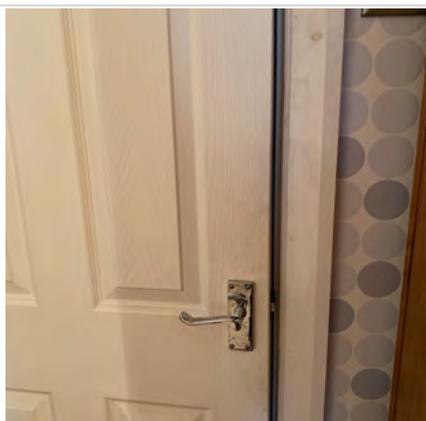
(Condition Rating 2)

The door does not close correctly and needs to be eased and adjusted.

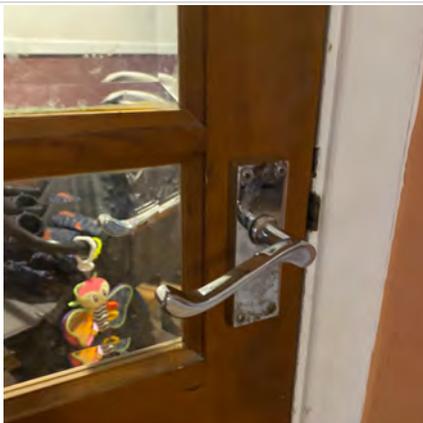
(Condition Rating 2)

The door does not close correctly and needs to be eased and adjusted.

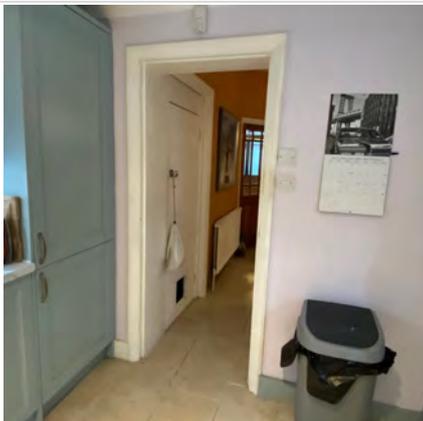
Kitchen 1

(Condition Rating 3)

Allow to replace missing door.

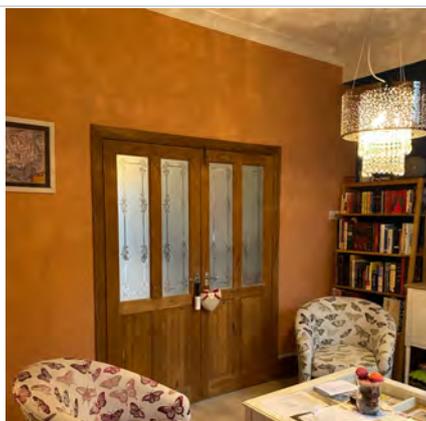
(Condition Rating 2)

This property would benefit from internal decorations.

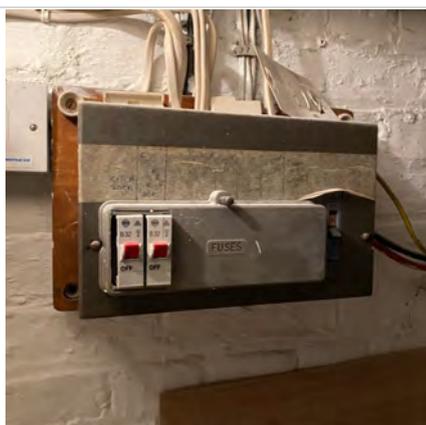
There is a mains supply and the electricity was on when we inspected. The consumer board and electricity meter are located in the basement. The consumer unit is a relatively old unit with old style electric fuses.

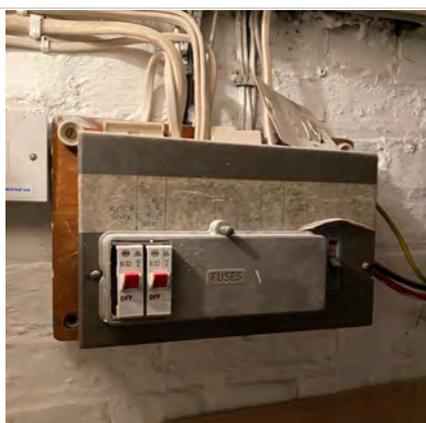
(Condition Rating 3)

We recommend a full rewire be carried out to this property.

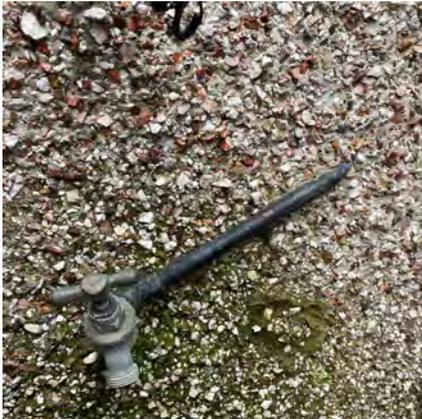
(Condition Rating 2)

There is no insulation to the third outside tap on the rear elevation. This needs to be insulated to protect the tap from freezing.

R6	Insulation: Allow to insulate external pipe to outside tap.		£20
R7	Allow to restitch missing brickwork. Brick pointing: Rake out existing joints of brickwork minimum of 12mm and repoint brickwork in mortar to match existing.		£200
R8	Remove and re-fix gutter: Take down any PVC gutter, remove and re-fix brackets to fascia and re-fix gutter to brackets to line and level including all angles, outlets, stop ends and remake all joints. Allow to clean vegetation from all gutters and downpipes and leave watertight.		£200
R9	Render plinth: Renew external rendering to plinth by hacking off the existing, raking out joints, hacking for key, and rendering in cement and sand, 15mm thick in two coats with steel trowelled surface, including flush joints including all necessary beads.		£200
R10	Fencing: Allow to replace rear fencing. Allow to remove defective fencing and erect interwoven/overlap fencing complete with 1.8x1.8m panels fixed to 100x100 Precast concrete posts. Allow for all excavation, concrete, backfill and remove surplus.		£300

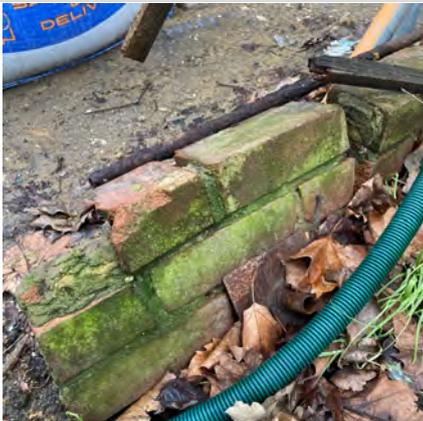
(Condition Rating 2)

The boundary wall is loose and needs to be re-built.

Cost of associated remedial work detailed in Section C, R5.

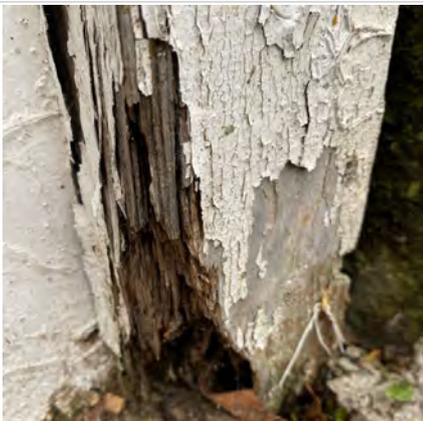
(Condition Rating 2)

The redundant timber post adjacent to the main entrance door is rotting.

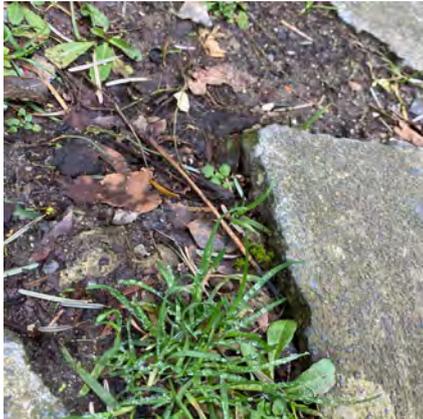
(Condition Rating 2)

The hard standing to the front is uneven due to missing paving slabs.

Cost of associated remedial work detailed in Section C, R57.

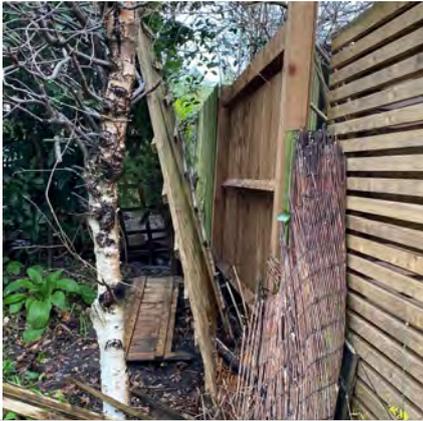
(Condition Rating 2)

The fencing to the rear is in poor condition and needs to be replaced.

Cost of associated remedial work detailed in Section C, R10.
