B About the inspection (continued)

Overall opinion

This property is generally in poor condition. There have been repairs identified however and these are listed further on in the report.

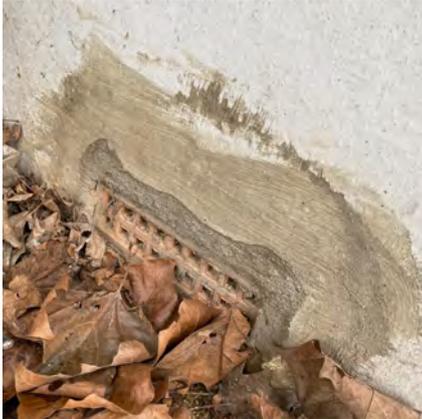
E9
Other

(Condition Rating 2)

External decorations are starting to deteriorate and would benefit from re-decoration. It is inevitable that some repairs and making good will be required when preparing to decorate, including isolated timber and masonry repairs.

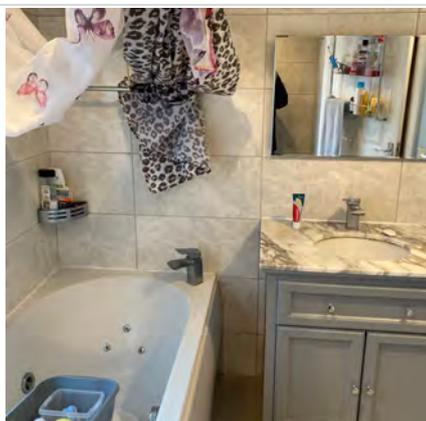
Bathroom 1

The bathroom has the following components: bath, wash hand basin, close-coupled WC, shower valve with shower head attachment and a shower curtain and rail.

The bathroom fittings and components in general are showing wear and tear, but are functional.

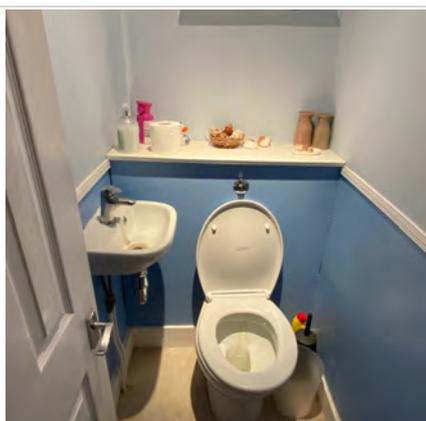
Separate Toilet 1

The separate toilet has the following components: wash hand basin and close-coupled WC.

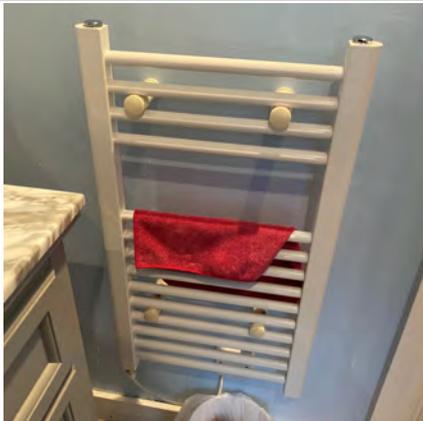
Bathroom 1

This area has an electric towel radiator.

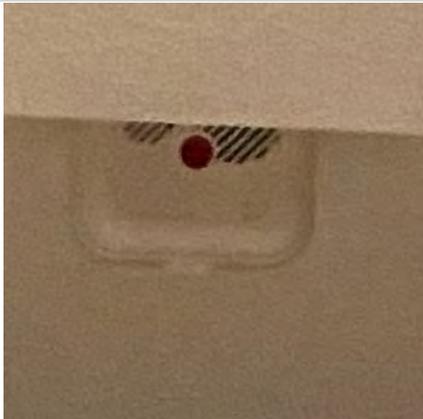
Hall 1

This area has a battery-operated smoke alarm.

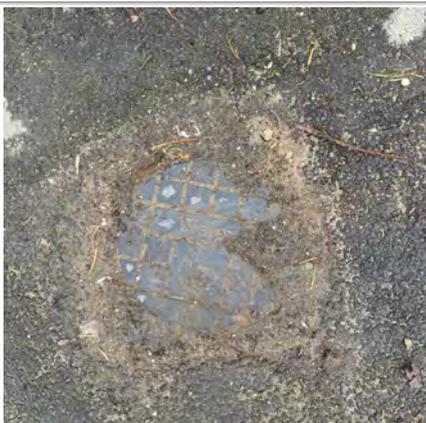
G3
Water

There is a mains water supply to the property. The main stopcock and the water meter are located on the front path.

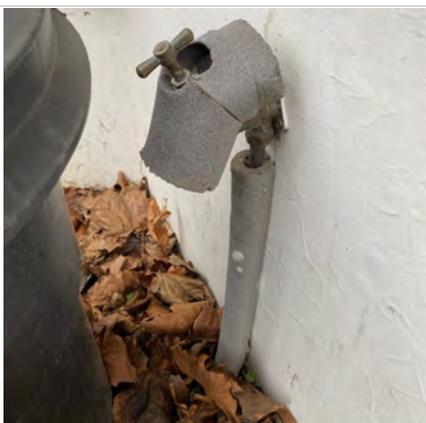
There is an outside tap located to the front.

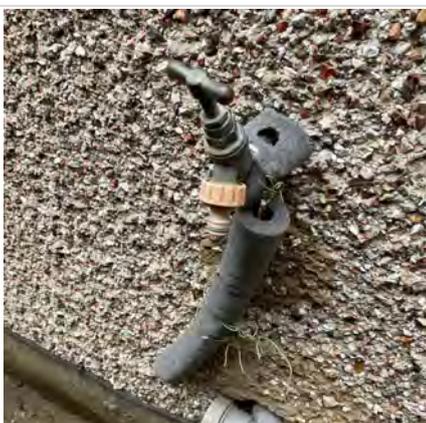
There is a second outside tap located to the rear.

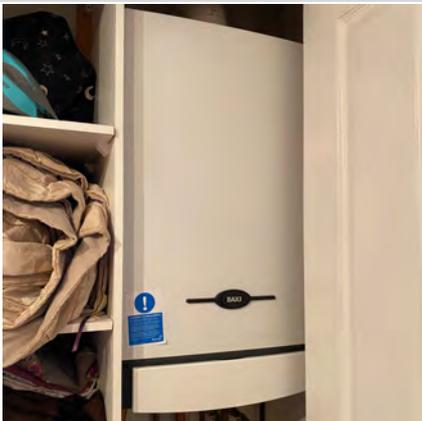
Adequate Heating System:

The gas fired, combination boiler in the bedroom 3 provides central heating throughout the accommodation. The central heating system was not in operation at the time of inspection and although the boiler is a relatively modern appliance, we cannot confirm that it is in safe working order. The boiler has an integral programmer.

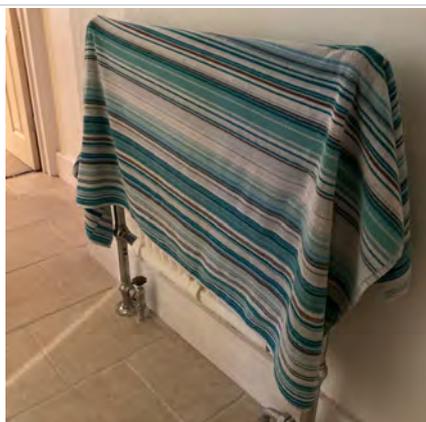
Landing 1

This room has a towel rail radiator.

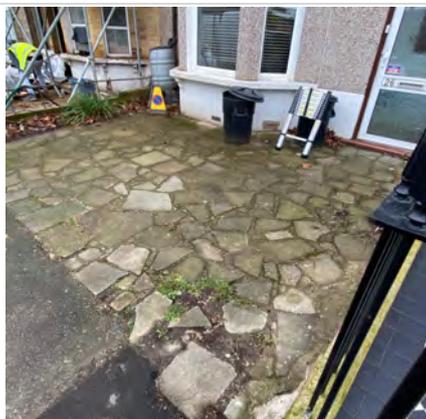
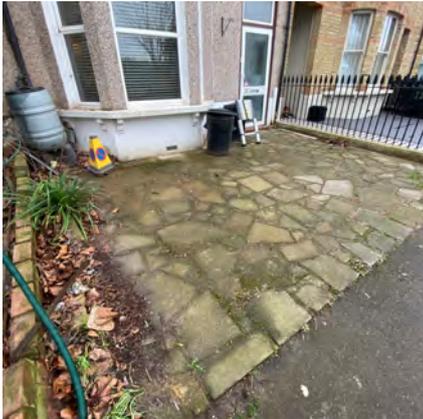
Landscape to front.

The hard standing to the front is uneven due to missing paving slabs.

Cost of associated remedial work detailed in Section C, R57.

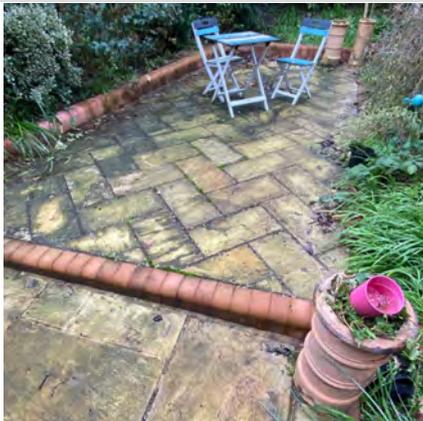
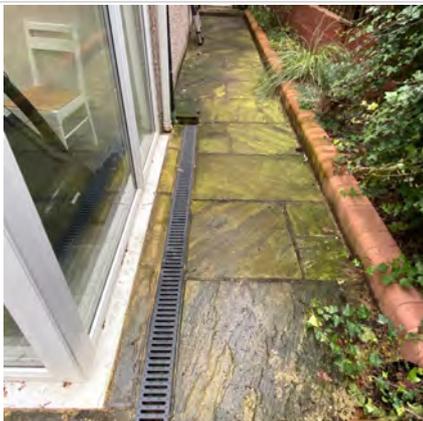
Landscape to rear.

The fencing to the rear is in poor condition and needs to be replaced.

Cost of associated remedial work detailed in Section C, R10.
